Windstorm Mitigation Report (OIR-B1-1802)

Bordeaux Village Association, No. 3, Inc.

13601 Frigate Ct., Building M, Units 101M-106M, 203M-204M

As of 12-07-2023 | FPAT File# MUD2320925

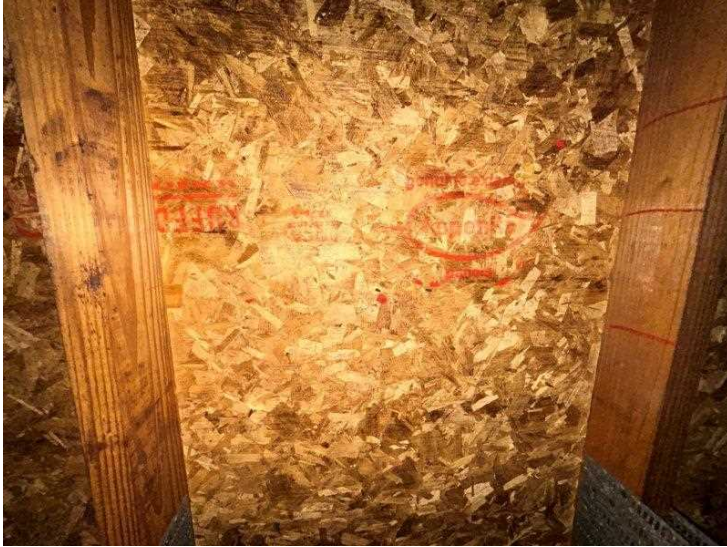
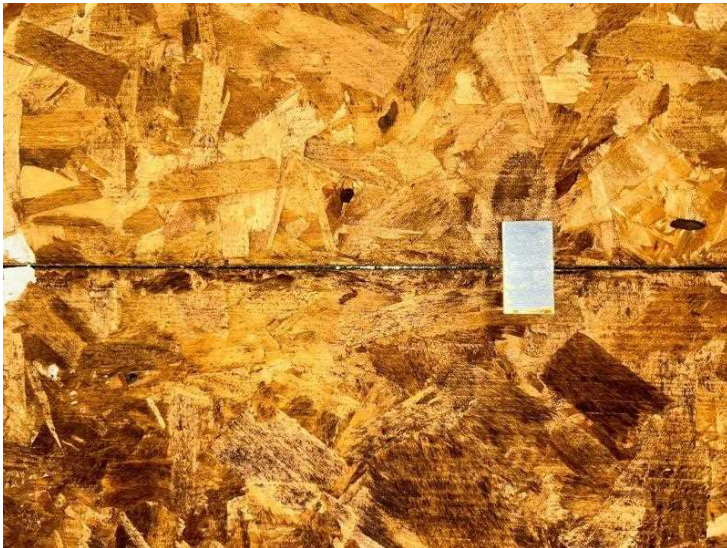
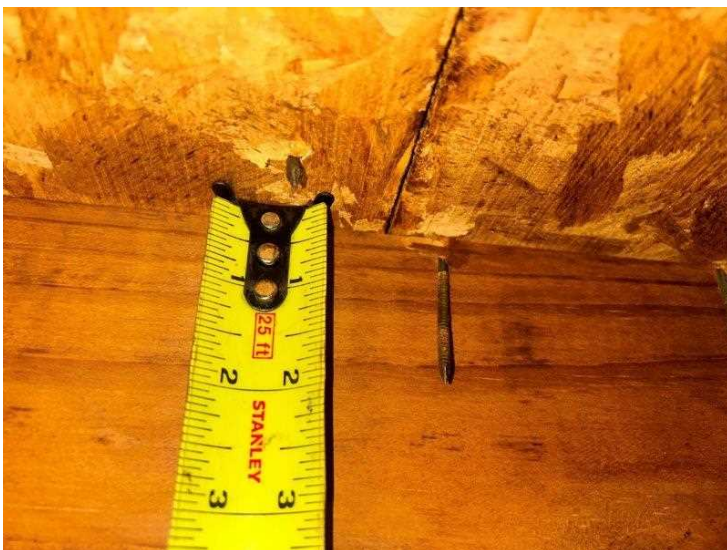
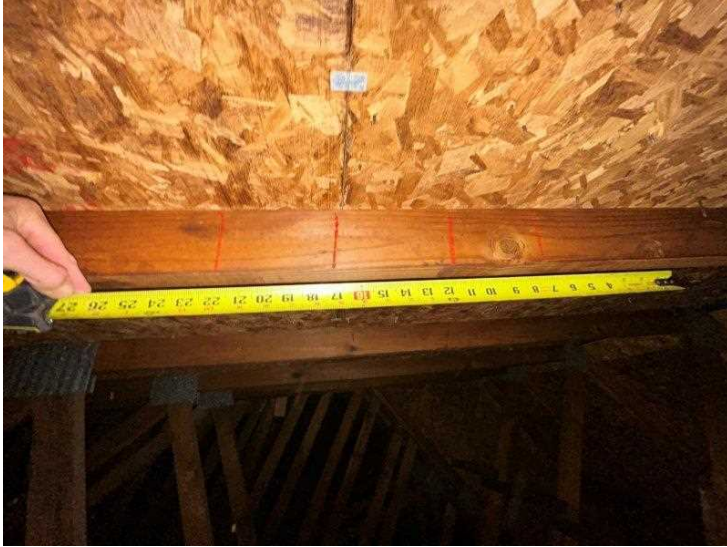
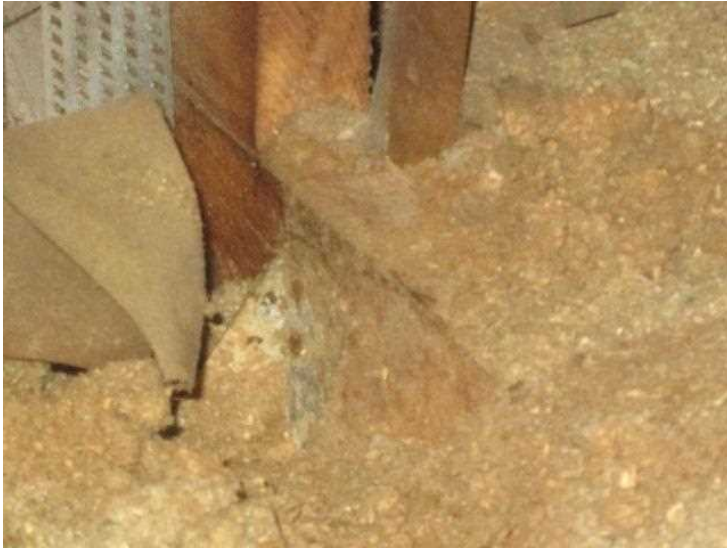
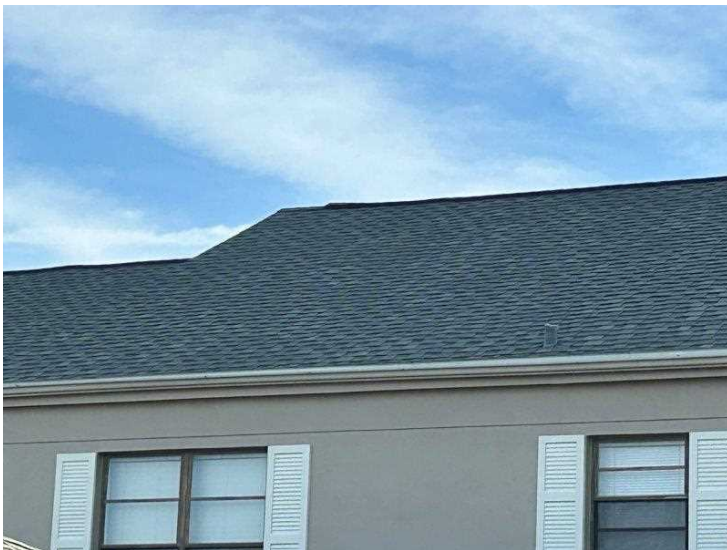
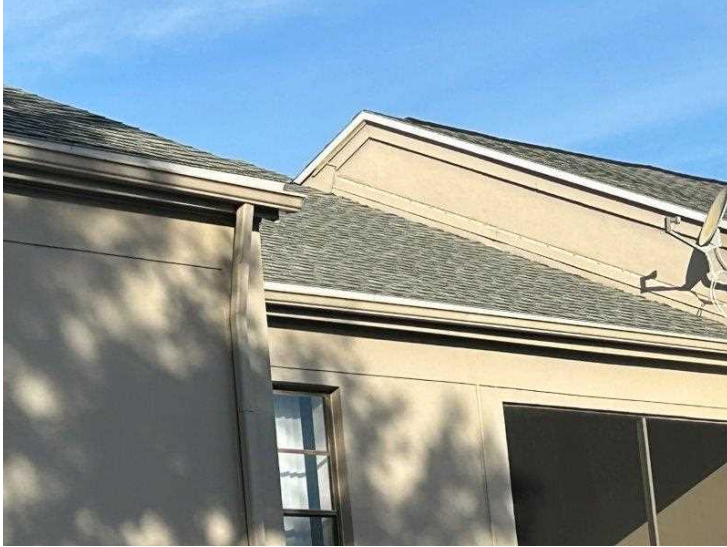
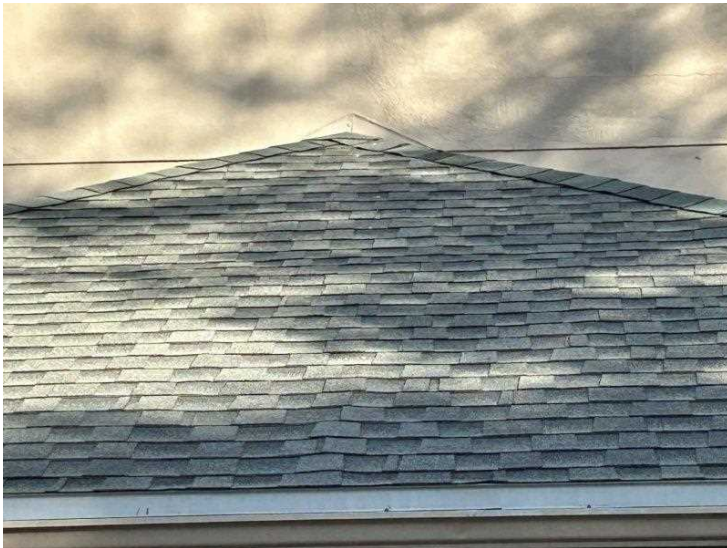
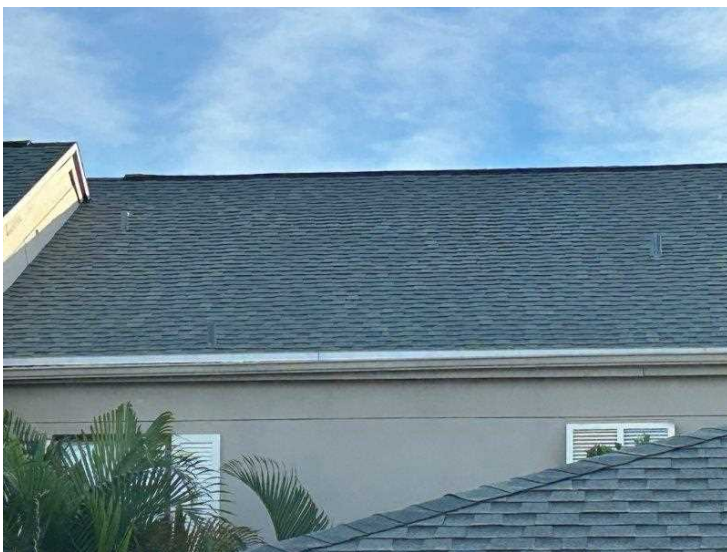
Roof Construction

Comments: | Level C
Inspection verified 1/2" OSB roof deck attached with 8d nails at a minimum 6" on the edge & 6" in the field |

Comments: | Clips
Inspection verified hurricane clips fastened with a minimum of three nails. |

Comments: | Other Roof
Inspection verified a gable roof shape. |

Comments: | Yes
SWR was verified at time of inspection. The Secondary Water Resistance verified is a self-adhering peel and stick. |
