Windstorm Mitigation Report (OIR-B1-1802)

Bordeaux Village Association, No. 3, Inc.

2453 Egret Blvd. Building O, Units 1010-1040, 2010-2040

As of 12-07-2023 | FPAT File# MUD2320925

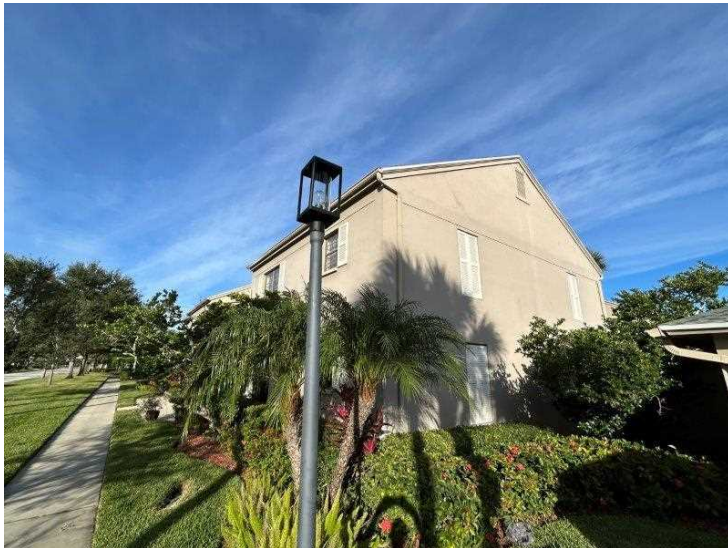
Exterior Elevation

Comments: | Other Roof
Inspection verified a gable roof shape. |

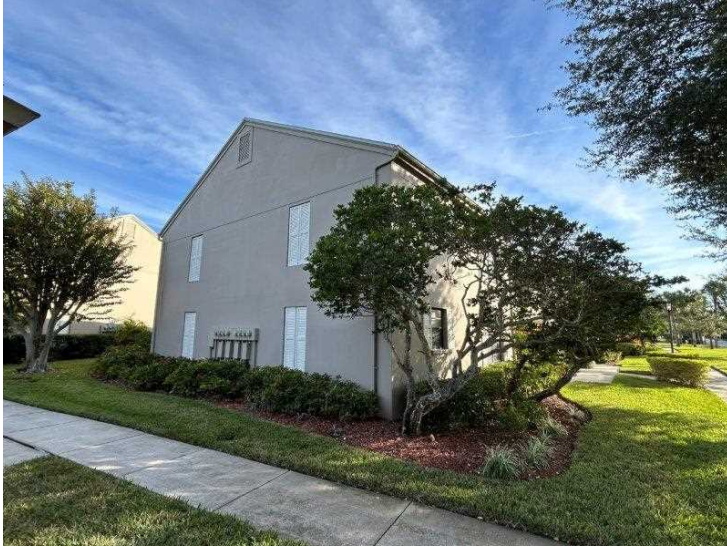
Exterior Elevation

Comments: | None or Some Glazed Openings
No opening protection verified at the time of inspection. |

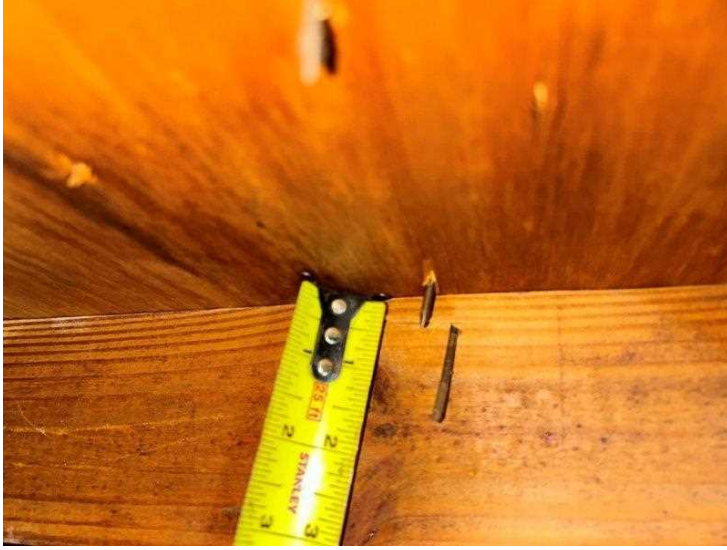
Roof Construction

Comments: | Level C
Inspection verified 1/2" plywood roof deck attached with 8d nails at a minimum 6" on the edge & 6" in the field. |

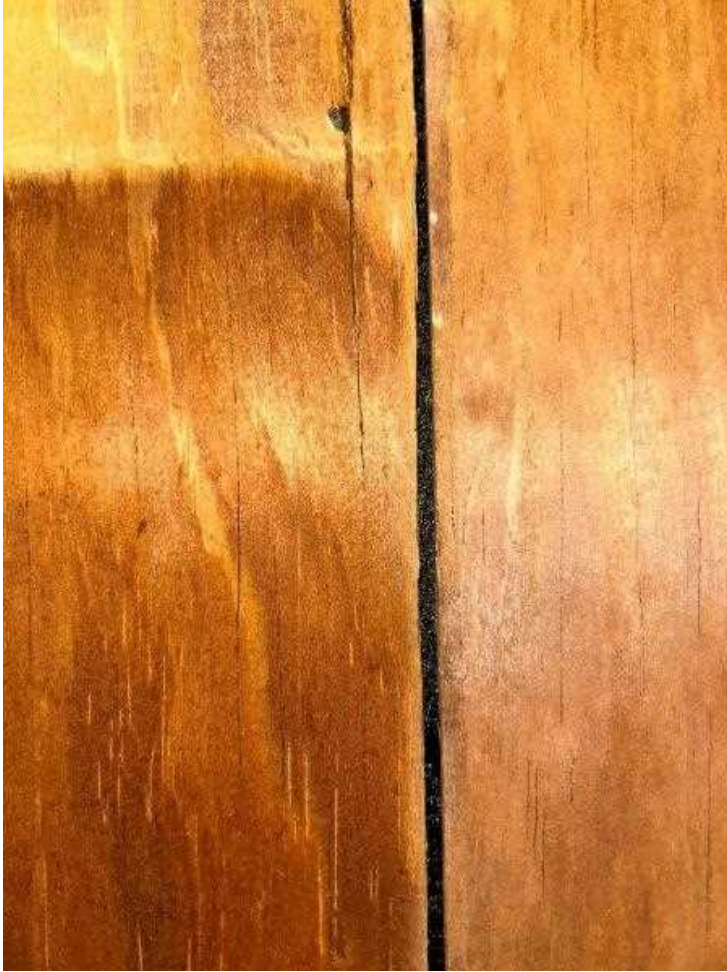
Roof Construction

Comments: | Clips
Inspection verified hurricane clips fastened with a minimum of three nails. |

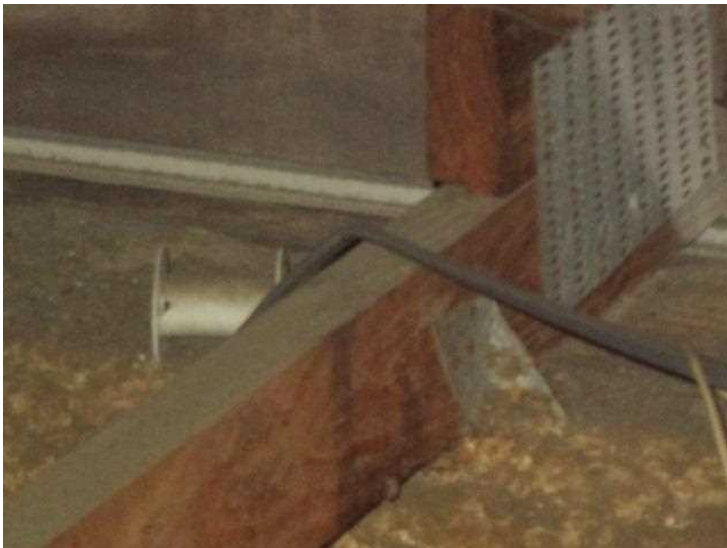
Roof Construction

Comments: | Yes
SWR was verified at time of inspection. The Secondary Water Resistance verified is a self-adhering peel and stick. |
