## Windstorm Mitigation Report (OIR-B1-1802)

Bordeaux Village Association, No. 3, Inc.

2480 Pelican Ct. Building R, Units 101R-103R, 201R-202R

As of 12-07-2023 | FPAT File# MUD2320925

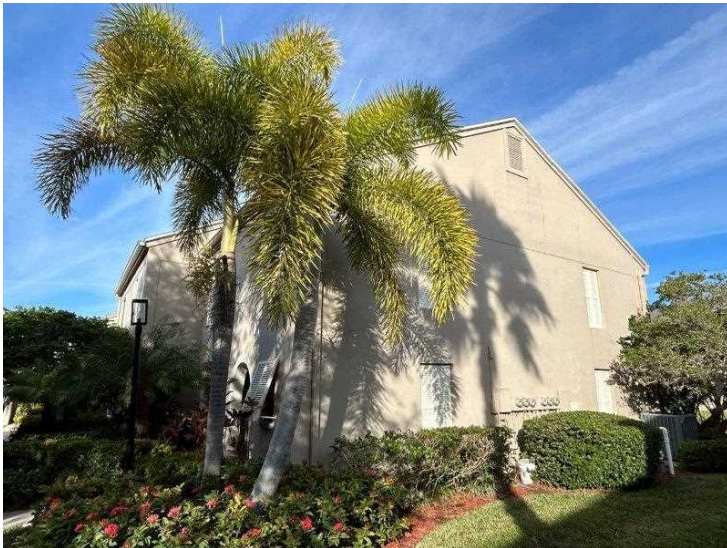
Exterior Elevation

| <b>5. Roof Geometry:</b><br>Comments: | <b>Other Roof</b><br>Inspection verified a gable roof shape. |

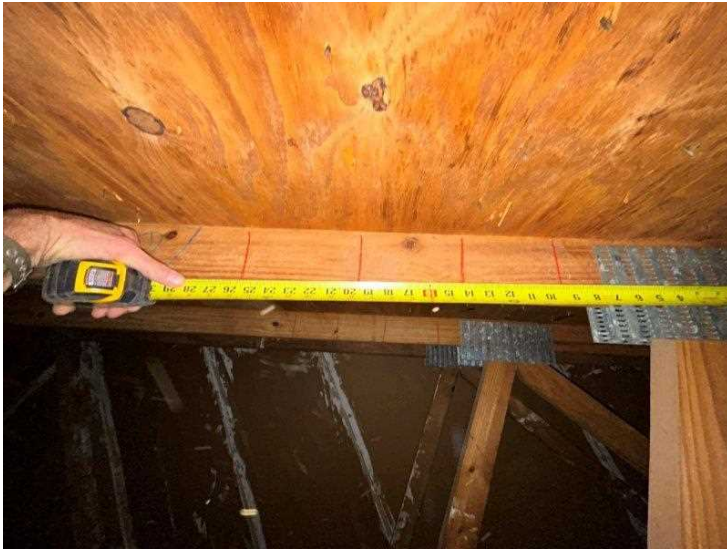
Roof Construction

| <b>3. Roof Deck Attachment:</b><br>Comments: | <b>Level C</b><br>Inspection verified 1/2" plywood roof deck attached with 8d nails at a minimum 6" on the edge & 6" in the field. |
