## Windstorm Mitigation Report (OIR-B1-1802)

Bordeaux Village Association, No. 3, Inc.

2450 Pelican Ct, Building Q, Units 101Q-105Q, 202Q, 203Q

As of 12-07-2023 | FPAT File# MUD2320925

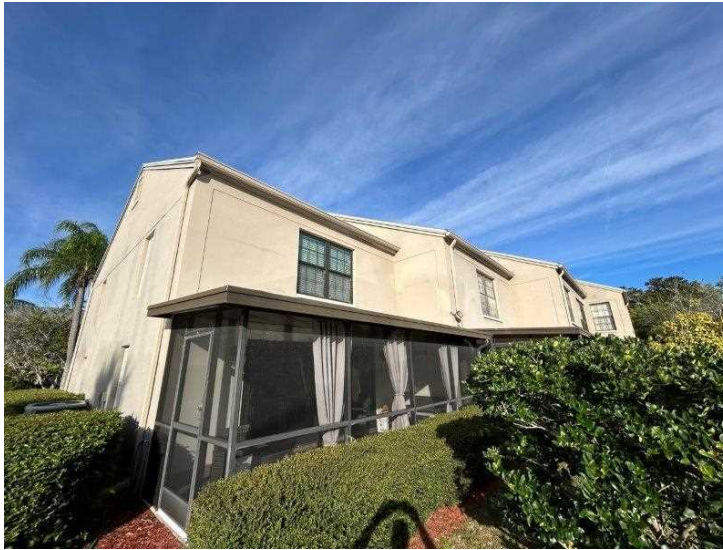
Record EBP-22-16838:  
Express Building Permit  
Record Status: Finald

BUILDING Q - 78sq; remove existing roof, re-nail deck, install  
peel & stick underlayment (FL# 5259.2), install new shingles  
(FL# 10124.1). 2 stories, 5/12 pitch

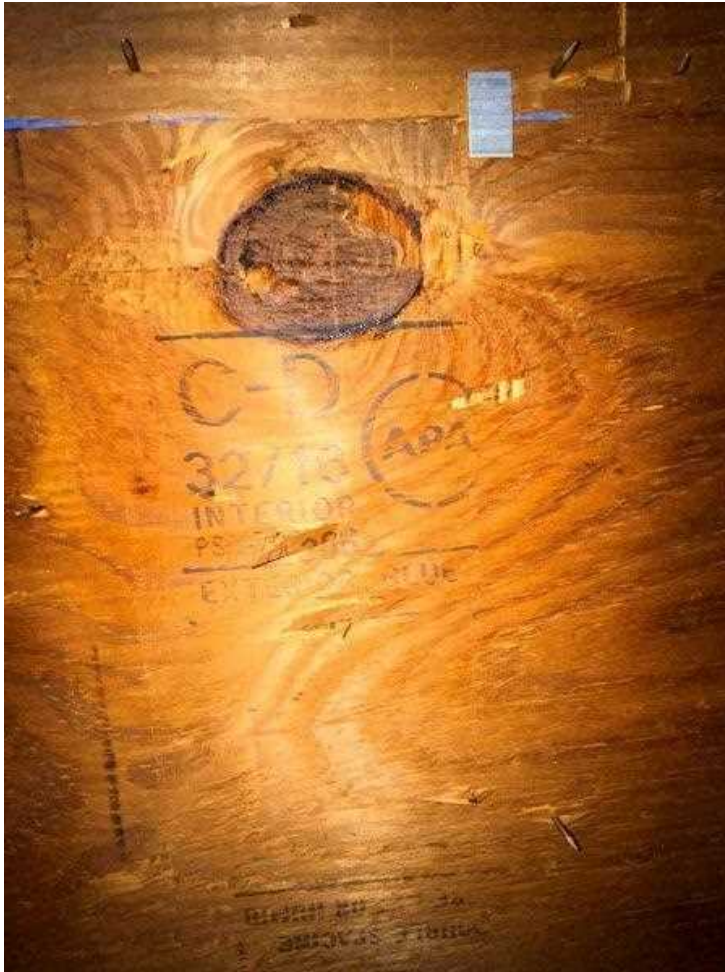
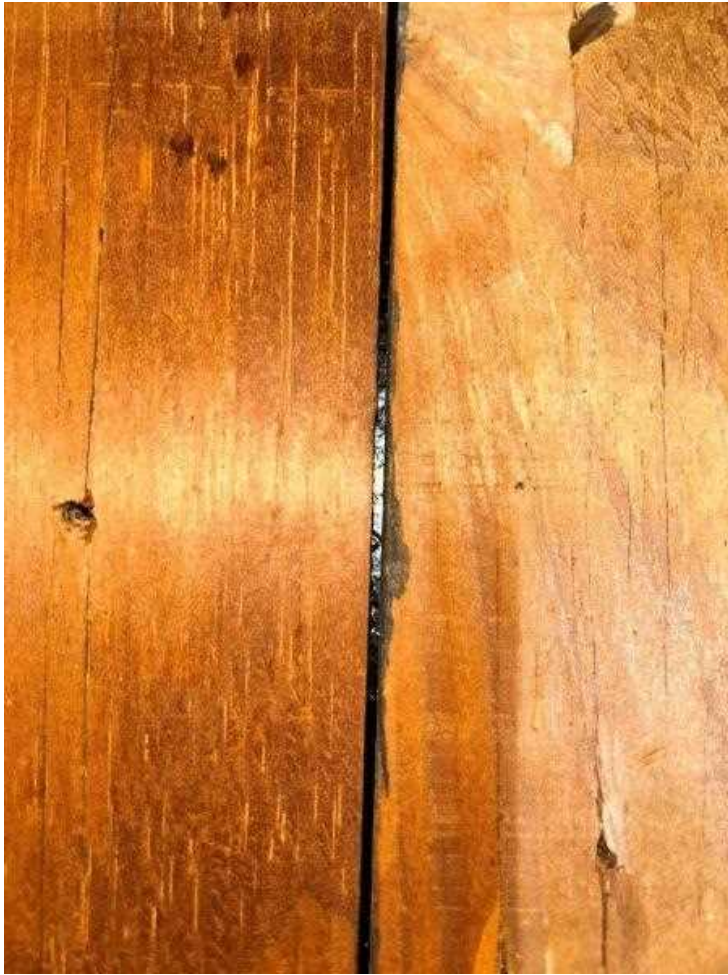
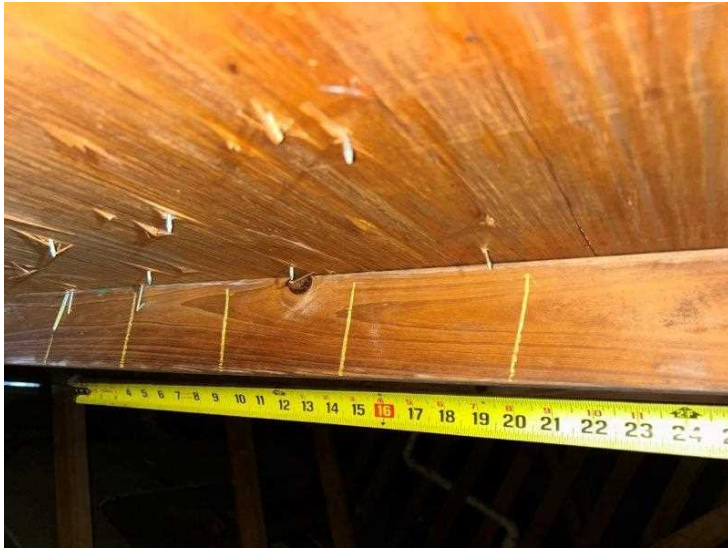
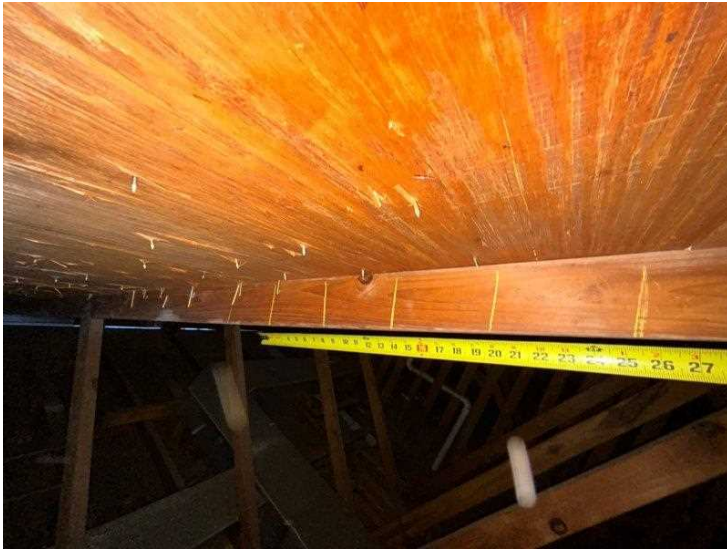
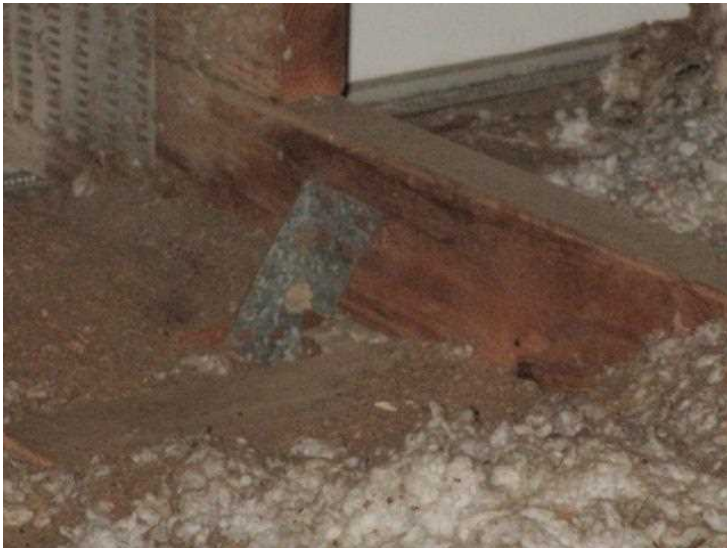
Roof Construction

| <b>3. Roof Deck Attachment:</b><br>Comments: | <b>Level C</b><br>Inspection verified 1/2" plywood roof deck attached with 8d nails at a minimum 6" on the edge & 6" in the field. |
| <b>4. Roof to Wall Attachment:</b><br>Comments: | <b>Clips</b><br>Inspection verified hurricane clips fastened with a minimum of three nails.. |
| <b>6. SWR:</b><br>Comments: | <b>Yes</b><br>SWR was verified at time of inspection. The Secondary Water Resistance verified is a self-adhering peel and stick. |
