Uniform Mitigation Verification Inspection Form

Inspection Date: 4 - 10 - 2017		
Owner Information		
Owner Name: Bordeaux Village 3		Contact Person:
Address: 13601 Frigate Ct Bldg. M		Home Phone:
City: Clearwater	Zip: 33762	Work Phone:
County: Pinellas		Cell Phone:
Insurance Company:		Policy #:
Year of Home: 1981	# of Stories: Two	Email:

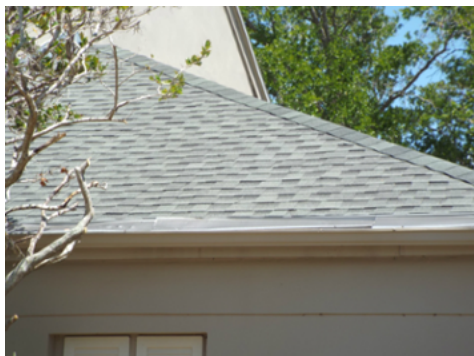
Roof - 1

2.1 Roof Covering Type:	Permit Application Date	FBC or MDC Product Approval #	Year of Original Installation or Replacement	No Information Provided for Compliance
<input checked="" type="checkbox"/> 1. Asphalt/Fiberglass Shingle	1 - 23 - 2017			<input type="checkbox"/>
<input type="checkbox"/> 2. Concrete/Clay Tile				<input type="checkbox"/>
<input type="checkbox"/> 3. Metal				<input type="checkbox"/>
<input type="checkbox"/> 4. Built Up				<input type="checkbox"/>
<input type="checkbox"/> 5. Membrane				<input type="checkbox"/>
<input type="checkbox"/> 6. Other _____				<input type="checkbox"/>

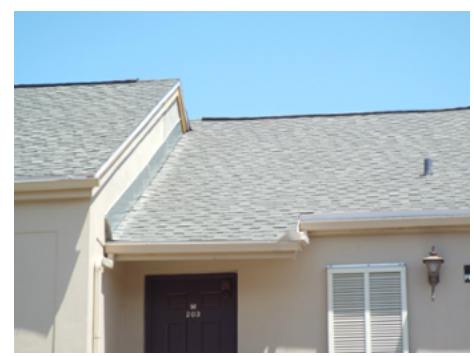
Roof - 2

5. **Roof Geometry:** What is the roof shape? (Do not consider roofs of porches or carports that are attached only to the fascia or wall of the host structure over unenclosed space in the determination of roof perimeter or roof area for roof geometry classification).

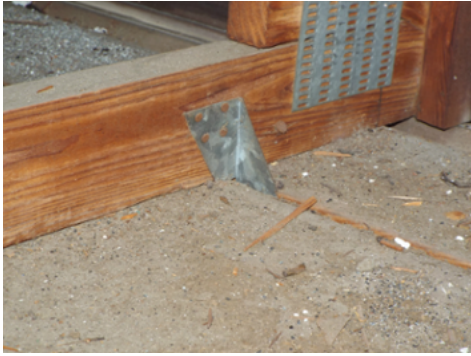
Clip - 1

- B. Clips
 - Metal connectors that do not wrap over the top of the truss/rafter, **or**
 - Metal connectors with a minimum of 1 strap that wraps over the top of the truss/rafter and does not meet the nail position requirements of C or D, but is secured with a minimum of 3 nails.

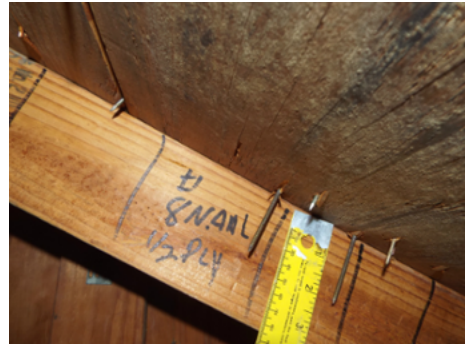
Nail Size

3. **Roof Deck Attachment:** What is the weakest form of roof deck attachment?

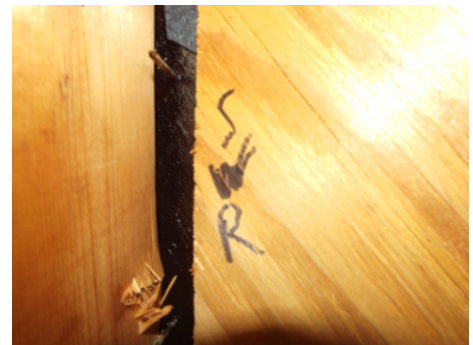
SWR

6. **Secondary Water Resistance (SWR):** (standard underlayments or hot-mopped felts do not qualify as an SWR)
