Uniform Mitigation Verification Inspection Form

Inspection Date: 4 - 10 - 2017		
Owner Information		
Owner Name: Bordeaux Village 3		Contact Person:
Address: 13602 Frigate Ct Bldg. N		Home Phone:
City: Clearwater	Zip: 33762	Work Phone:
County: Pinellas		Cell Phone:
Insurance Company:		Policy #:
Year of Home: 1981	# of Stories: Two	Email:

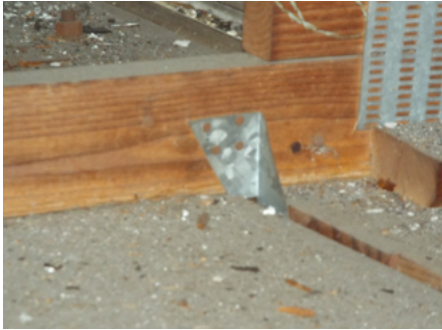
Clip - 1

- B. Clips
 - Metal connectors that do not wrap over the top of the truss/rafter, **or**
 - Metal connectors with a minimum of 1 strap that wraps over the top of the truss/rafter and does not meet the nail position requirements of C or D, but is secured with a minimum of 3 nails.
- C. Single Wraps
