## COMMERCIAL WINDSTORM MITIGATION REPORT

Bordeaux Village Association, No. 3, Inc.

## COMMERCIAL WINDSTORM MITIGATION REPORT (OIR-B1-1802)

13603 Stork Ct, Building P, Units 101P-105P, 202P-205P

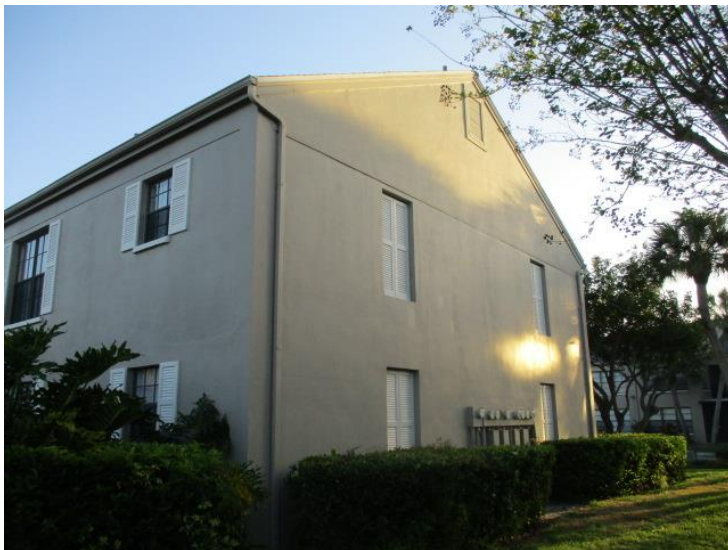
Exterior Elevation

5. **Roof Geometry:**                      **Other Roof**  
Comments:                                      Inspection verified a predominately gable roof shape with some hip portions. The gable sections of the roof account for greater than 10% of the total roof perimeter.

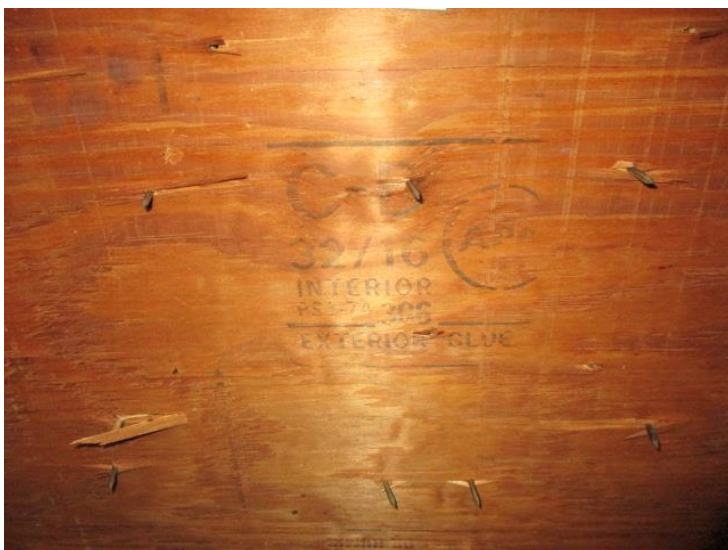
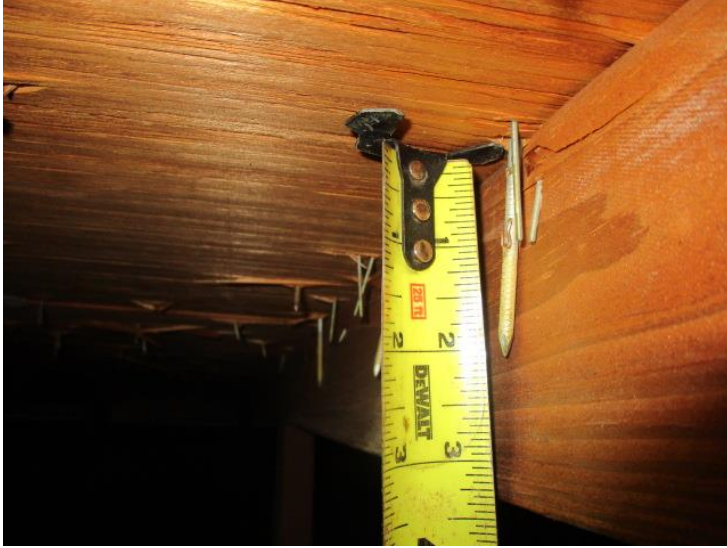
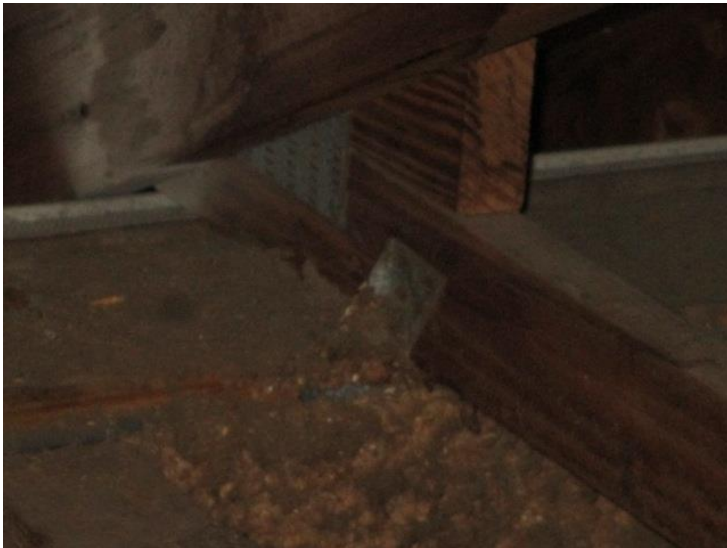
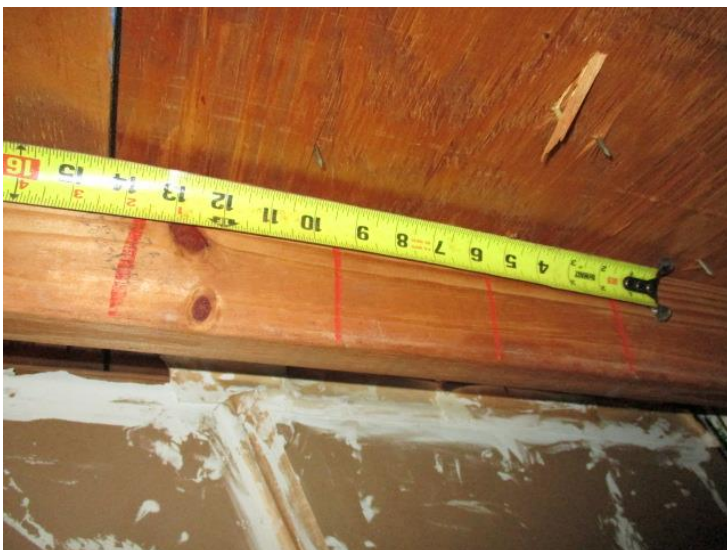
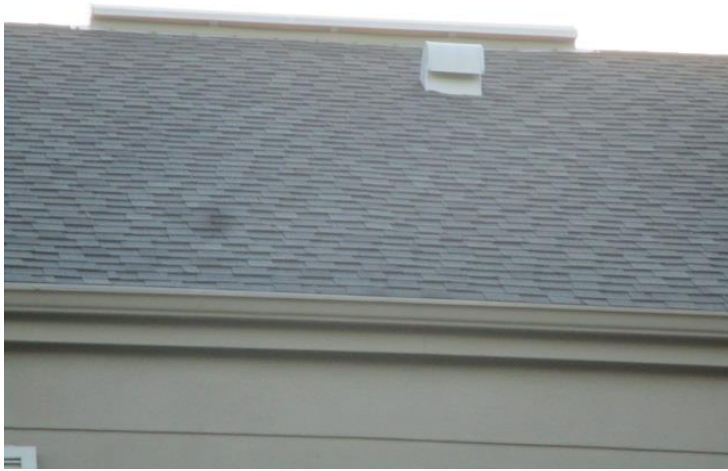
Roof Construction

3. **Roof Deck Attachment:**        **Level C**  
Comments:                                      Inspection verified 1/2" plywood roof deck attached with 8d nails at a minimum 6" on the edge & 6" in the field.

4. **Roof to Wall Attachment:**        **Clips**  
Comments:                                      Inspection verified hurricane clips fastened with a minimum of three nails..

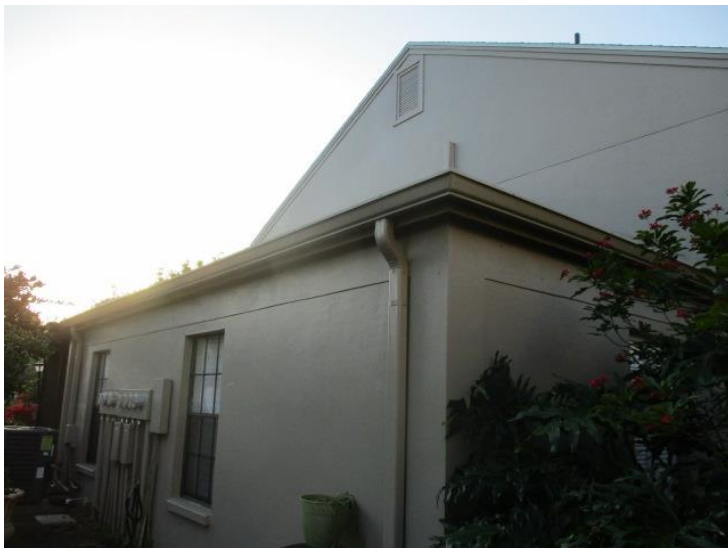
Exterior Elevation

- 5. Roof Geometry:**                      **Other Roof**  
Comments:                                      Inspection verified a predominately gable roof shape with some hip portions. The gable sections of the roof account for greater than 10% of the total roof perimeter.

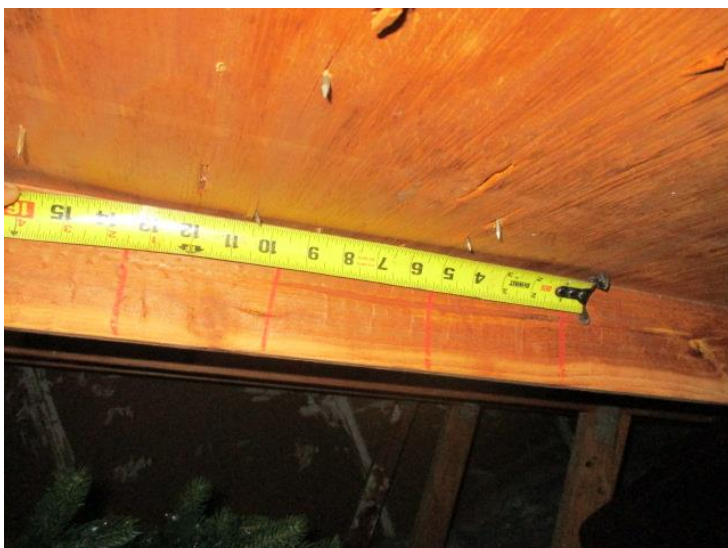
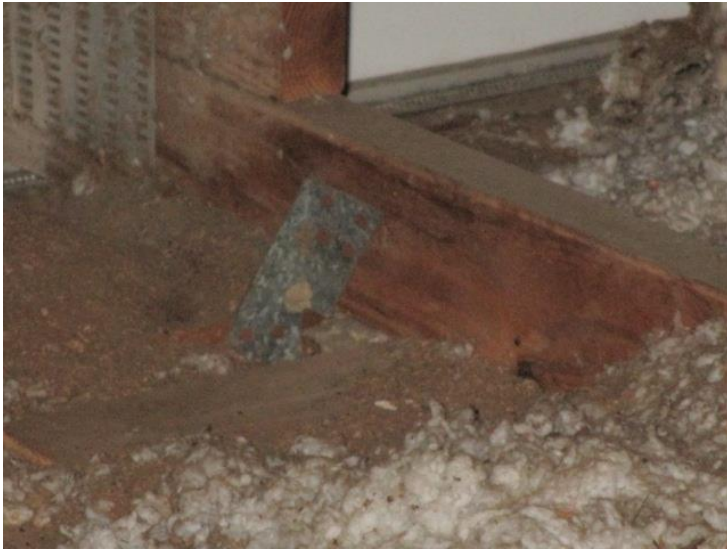
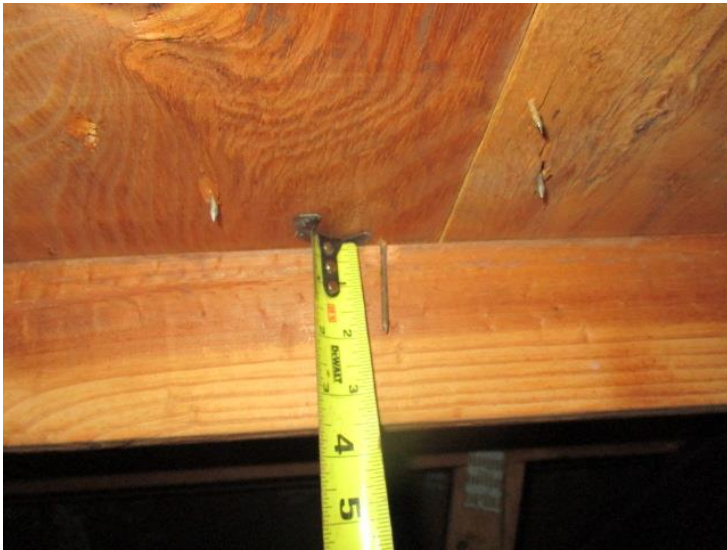
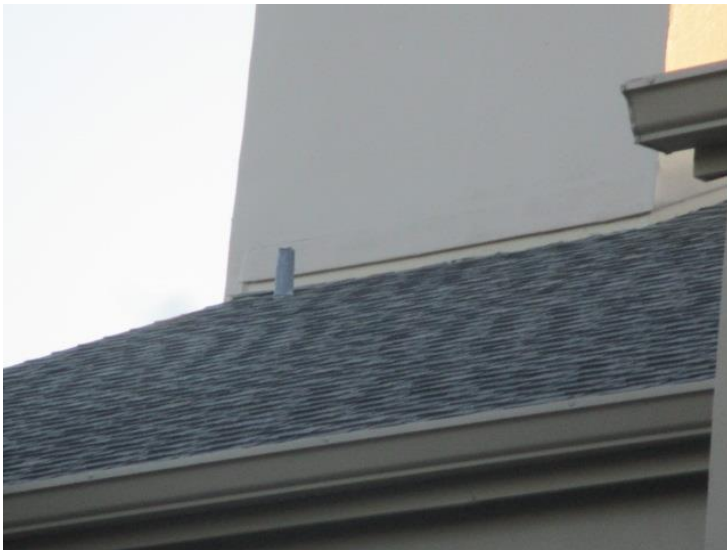
Roof Construction

- 3. Roof Deck Attachment:**        **Level C**  
Comments:                                      Inspection verified 1/2" plywood roof deck attached with 8d nails at a minimum 6" on the edge & 6" in the field.

- 4. Roof to Wall Attachment:**        **Clips**  
Comments:                                      Inspection verified hurricane clips fastened with a minimum of three nails..
