# Uniform Mitigation Verification Inspection Form

Inspection Date: 4 - 10 - 2017		
<b>Owner Information</b>		
Owner Name: Bordeaux Village 3		Contact Person:
Address: 2480 Pelican Ct. Bldg. R		Home Phone:
City: Clearwater	Zip: 33762	Work Phone:
County: Pinellas		Cell Phone:
Insurance Company:		Policy #:
Year of Home: 1981	# of Stories: Two	Email:

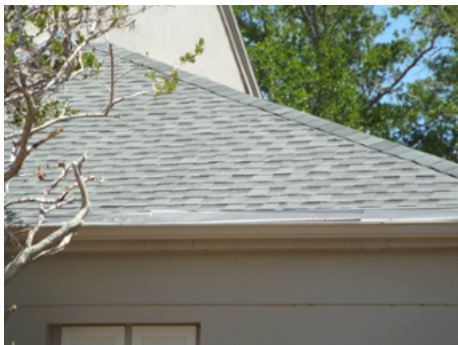
Roof - 1

2.1 Roof Covering Type:	Permit Application Date	FBC or MDC Product Approval #	Year of Original Installation or Replacement	No Information Provided for Compliance
<input checked="" type="checkbox"/> 1. Asphalt/Fiberglass Shingle	1 - 23 - 2017			<input type="checkbox"/>
<input type="checkbox"/> 2. Concrete/Clay Tile				<input type="checkbox"/>
<input type="checkbox"/> 3. Metal				<input type="checkbox"/>
<input type="checkbox"/> 4. Built Up				<input type="checkbox"/>
<input type="checkbox"/> 5. Membrane				<input type="checkbox"/>
<input type="checkbox"/> 6. Other _____				<input type="checkbox"/>

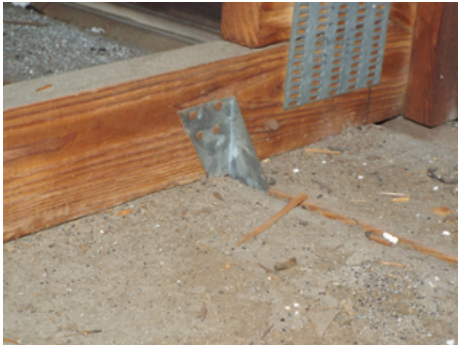
Clip - 1

- B. Clips
  - Metal connectors that do not wrap over the top of the truss/rafter, **or**
  - Metal connectors with a minimum of 1 strap that wraps over the top of the truss/rafter and does not meet the nail position requirements of C or D, but is secured with a minimum of 3 nails.
- C. Single Wraps

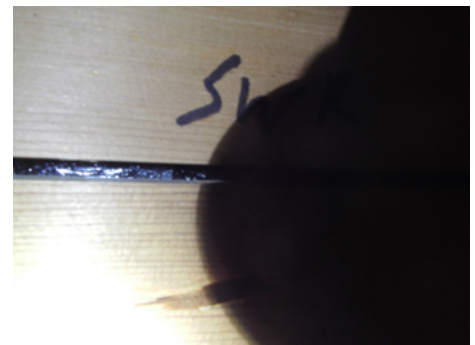
- A. SWR (also called Sealed Roof Deck) Self-adhering polymer modified-bitumen roofing underlayment applied directly to the sheathing or foam adhesive SWR barrier (not foamed-on insulation) applied as a supplemental means to protect the dwelling from water intrusion in the event of roof covering loss.
- B. No SWR.
- C. Unknown or undetermined.
